PIPELINE OBSERVATION SYSTEM MANAGEMENT
Project Information

Project: CITY OF MOUNTAIN VIEW

Upstream MH: F5-52

Downstream MH: F5-34

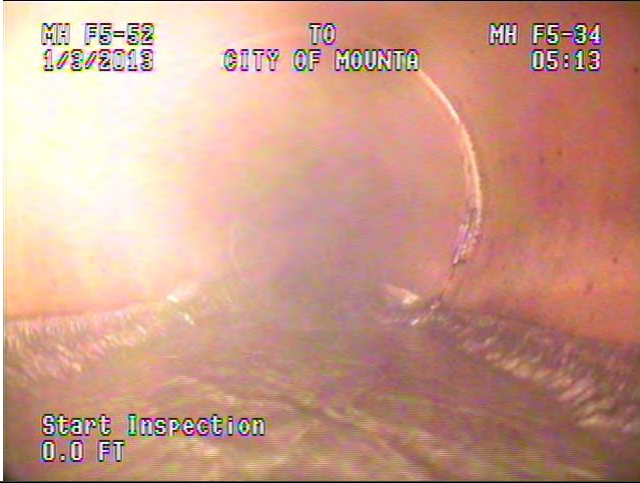
Distance	Fault Observation	Time	Picture
0.0	Start Inspection Severity: None Remarks: start	26

<p>MH F5-52 TO MH F5-34 1/3/2013 CITY OF MOUNTAIN VIEW 05:13</p> <p>Start Inspection 0.0 FT</p>
92.5	Infil Dripper Position: 12 Severity: None Maint Weight: 3	03:25

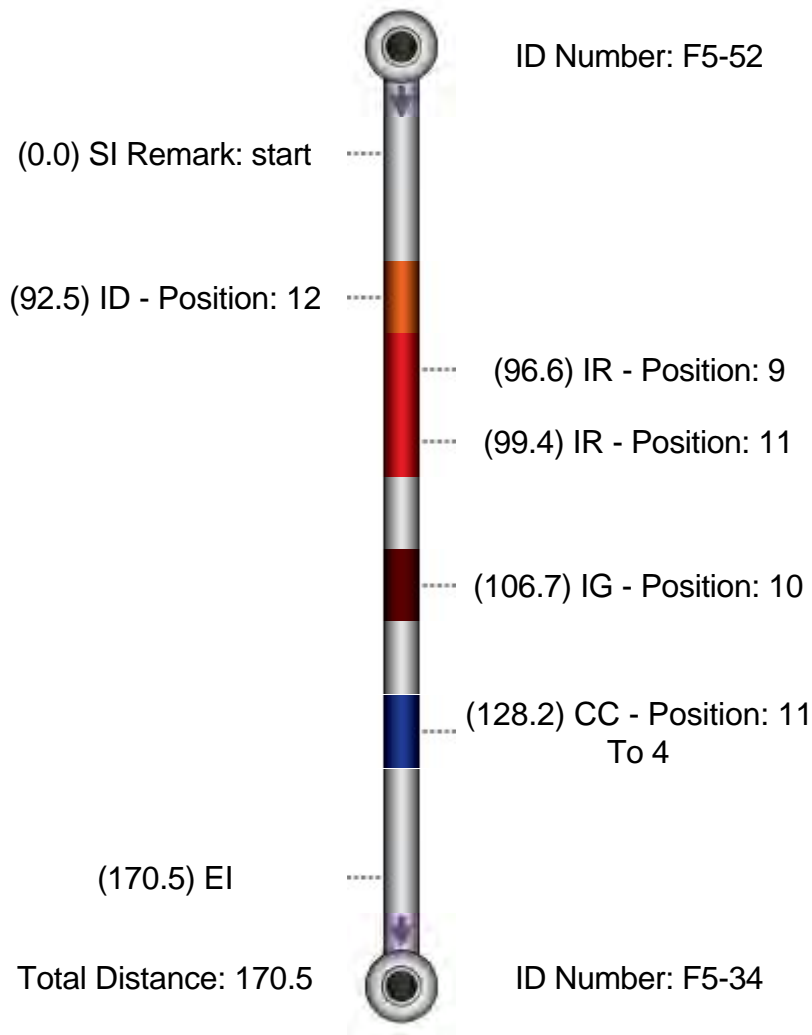
Severity
Light
Moderate
Average
Heavy
Severe
